SERVICE BULLETIN **Buell**[®]

B-024B

November 20, 2000

SAFETY RECALL CODE 0817 - REVISED SHOCK EYE

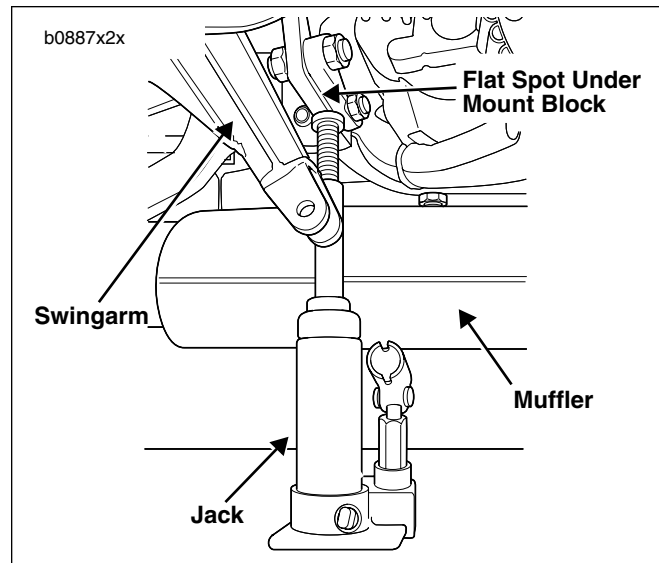
Figure 1. Jack Location on Mount Block (Shock Removed for Clarity)

2. Disconnect negative battery cable.
3. See Figure 1. Place a suitable jack under the swing arm mount block and raise until crankcase is supported by jack.

13. Lower and remove jack from under swing arm mount block.

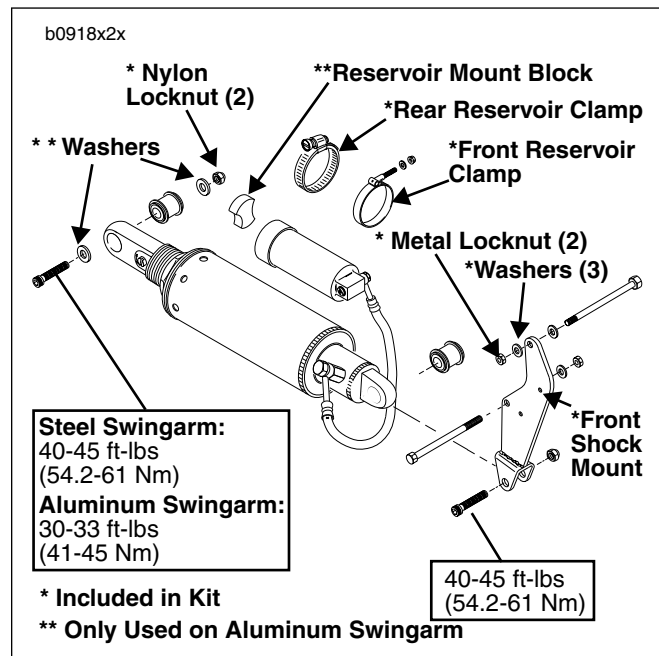
Figure 2. New Shock Absorber Assembly

4. See Figure 2. Use a flex socket and extension to remove locknut and washer on front reservoir clamp. Discard clamp, locknut and washer.
5. See Figure 2. Loosen rear reservoir clamp. Slide reservoir and mount block out of clamp. Remove and discard clamp and mount block.

1. See Figure 2. Install **new** front shock mount to crankcase with two **new** front shock mount bolts, washers, star washer (on 1997 M2, S3/S3T models only) and metal locknuts. Tighten bolts to 30-33 ft-lbs (41-45 Nm). **NOTE:** Top bolt goes in from the left side, bottom bolt goes in from right side. Bottom bolt does not use washer under bolt head. Star washer (only used on 1997 M2, S3/S3T models) goes on bottom bolt under the washer on the nut side. If exhaust was loosened during front shock mount removal, replace exhaust gaskets and reinstall exhaust. See appropriate Service Manual, Section 2 for instructions.

4. See Figure 2. Position **new** shock absorber from kit in mounting position.
5. Loosely install bolt, washers (aluminum swingarms only) and **new** locknut through rear shock eye and swing arm.
6. Loosely install bolt and **new** locknut through front shock eye and front shock mount.
7. **On 1996-1998 vehicles only:** Loosen header tie bar from collector.
8. Position front clamp over reservoir. Loosely install **new** front reservoir clamp to front shock mount (and install **new** header tie bar spacer between front shock mount and header tie bar on 1996-98 vehicles only) with **new** washer and **new** nylon locknut.
9. See Figure 3. Loosely install **new** rear clamp around reservoir and oil feed line.
10. **All Models:** Install **new** reservoir mount block between oil pump fitting and remote reservoir.

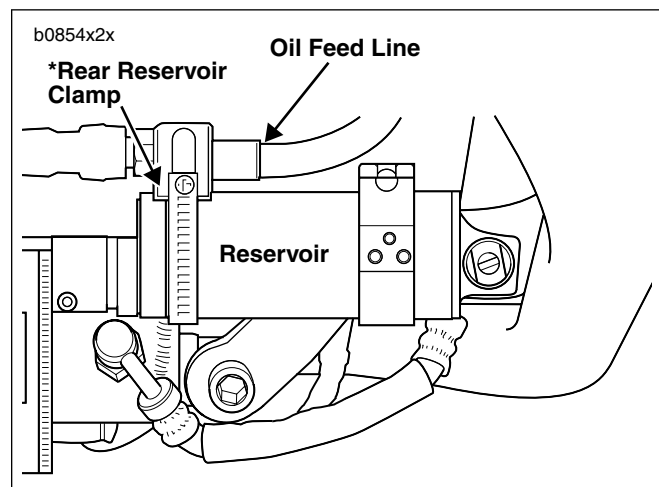
Figure 3. Rear Reservoir Clamp

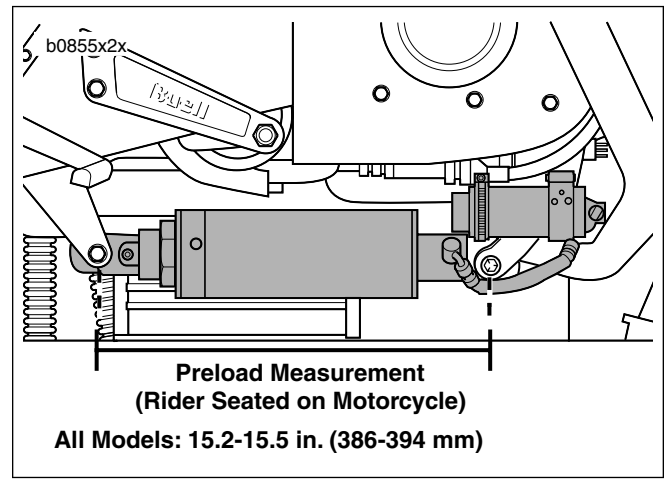
Figure 4. Measuring Preload

- See Figure 4. Check and adjust rear shock preload.
 - With rider seated on motorcycle, the preload is determined by measuring the distance between the centers of the front and rear shock eye and adjusting until the measurement is within specification.
 - See below for optimum preload measurements:
 - All Models:** 15.2-15.5 in. (386-394 mm)

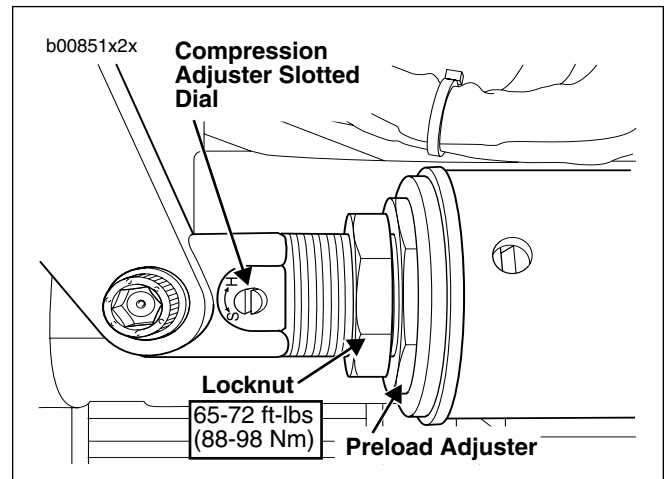
Figure 5. Preload and Compression Adjustments

- All measurements must be taken with rider seated on motorcycle.
 - Riders with passenger at or near GVWR may exceed optimum shock length measurement (preload adjustment).
- See Figure 5. To adjust shock preload, loosen the locknut and turn the preload adjuster at the end of the shock to move can towards front or rear of motorcycle.
 - Tighten adjuster (move can towards rear of motorcycle) to **increase** preload.
 - Loosen adjuster (move can towards front of motorcycle) to **decrease** preload.
 - See Figure 7. When finished, apply wheel bearing grease halfway around the shock (180 degrees) to the mating faces of the locknut and adjuster nut and the first few threads on the aluminum body leading to the adjuster nut.
 - Thread locknut back into place.

- See Figure 5. Set compression damping using the slotted dial on the shaft at the end of the shock. New factory setting is as listed below:
 - S1/S1W/M2 Models:** full damping minus 2.25 turns.

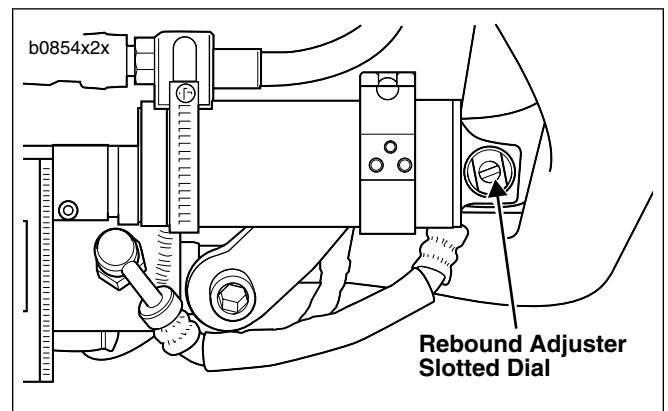
Figure 6. Rebound Adjustment

- S2/S2T Models:** full damping minus 2.5 turns.
 - S3/S3T Models:** full damping minus 2.5 turns.
 - See Figure 6. Set rebound damping using the slotted dial on the remote reservoir at the front of the shock. New factory setting is as listed below:

- S1/S1W/M2 Models:** full damping minus 1.5 turn.
 - S2/S2T Models:** full damping minus 1 turn.
 - S3/S3T Models:** full damping minus 1 turn.

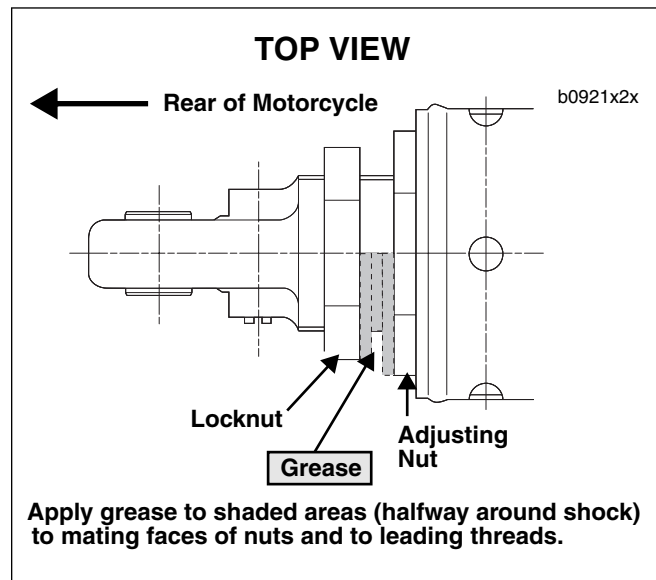
Figure 7. Locknut Tightening Procedure

- Using SHOCK PRELOAD ADJUSTING TOOLS (Part No. B-45110), hold adjusting nut in place with 60 mm ADJUSTING NUT WRENCH and tighten locknut to 65-72 ft-lbs (88-98 Nm) with 52 mm LOCKNUT CROW'S FOOT set at 90 degrees to the torque wrench.
- Wipe excess grease off of shock absorber.
